Manhole Inspection Summary

Manhole # S35W1_007MH

Insp Date: **11/19/07 12:41 PM**

Location Address: **3720 Potee St.**

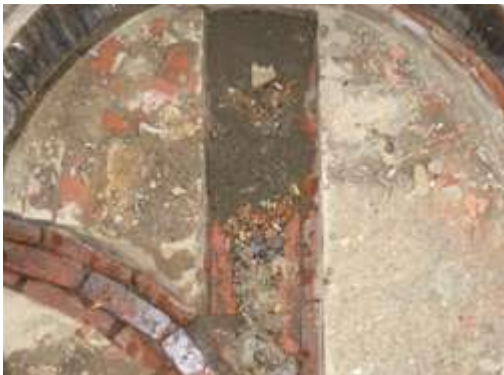
Defect 1

Condition: ☐ Sound ☐ Cracked ☐ Root Intrusion ☐ Deteriorated ☐ Leaks ☒ **Debris**

Debris on bench/in channel

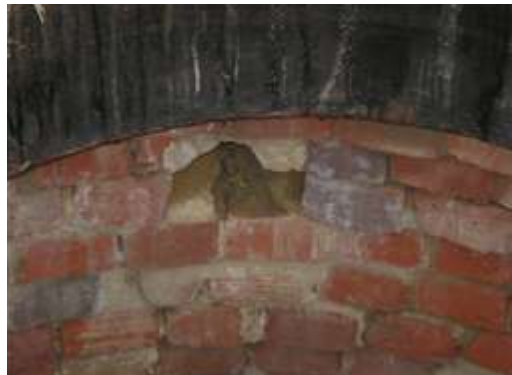
Defect 2

Offset: **5** (in.)

Condition: ☐ Sound ☐ Cracked ☐ Root Intrusion ☒ **Loose Brick** ☐ Deteriorated

Frame offset/missing brick in chimney

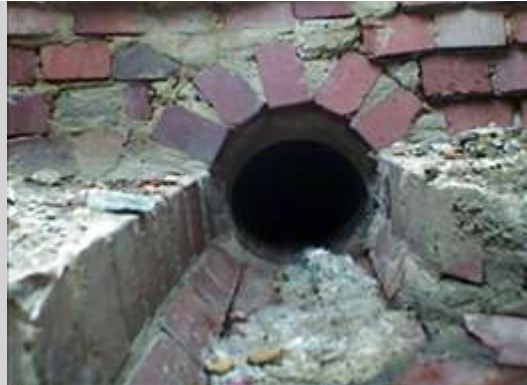
12 O'Clock Outflow

10 in. Circular Gravity Sewer
Pipe Out @ 12 O'Clock

Deposits: ☒ None ☐ Mud ☐ Sludge ☐ Debris ☐ Grease

Infiltration: **None** Pipe Seal Cond: **Sound**

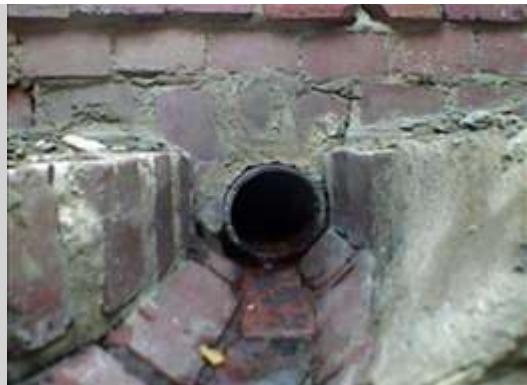
3 O'Clock Inflow

4 in. Circular Service Sewer
Pipe In @ 3 O'Clock

Deposits: ☒ None ☐ Mud ☐ Sludge ☐ Debris ☐ Grease

Infiltration: **None** Pipe Seal Cond: **Sound**
